Understanding Network Resources

By Cristhian Bermudez

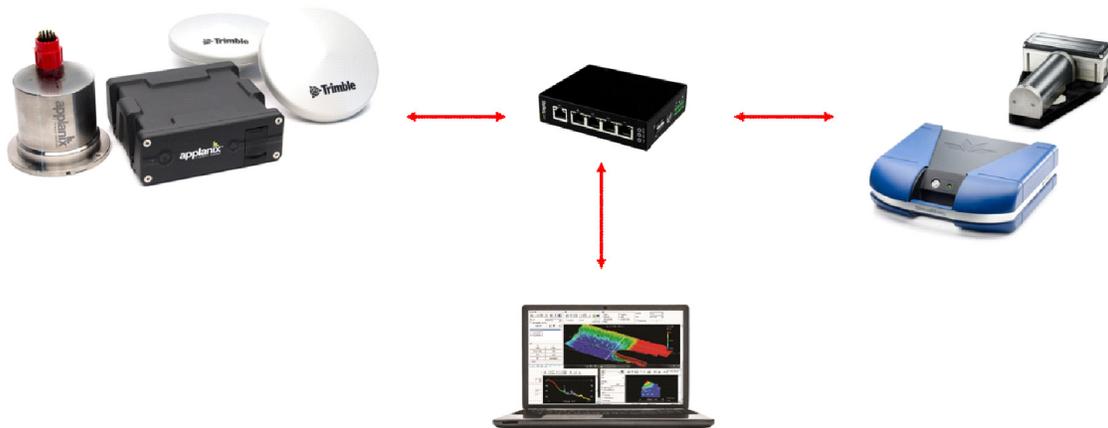
FIGURE 1. Hardware Setup

The user had a Teledyne T20-P and Applanix POS MV system. They were using a network switch to send all of the data to the computer running HYPACK:

The solution was simple, as I said before the user had an old network switch that only could negotiate Fast Ethernet connections (100 Mbps). He went to the electronics store and got an inexpensive switch, but in this case with Gigabit Ethernet interfaces (1000 Mbps).

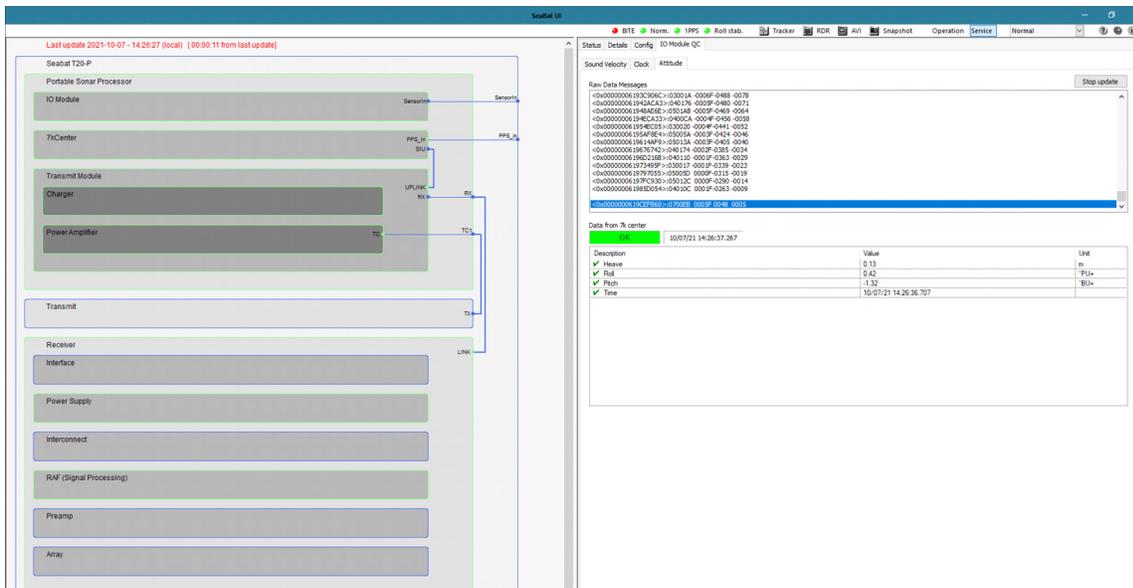
FIGURE 2. BITE Warning in SeaBat UI

In the SeaBat UI we saw some random warnings, in some cases it wasn't receiving the clock data coming from the POS MV and we saw the BITE blinking red. On the other hand, when we opened HYPACK and we noticed Hysweep Survey wasn't receiving data from the echosounder, we restarted all of the equipment, however the problem persisted.

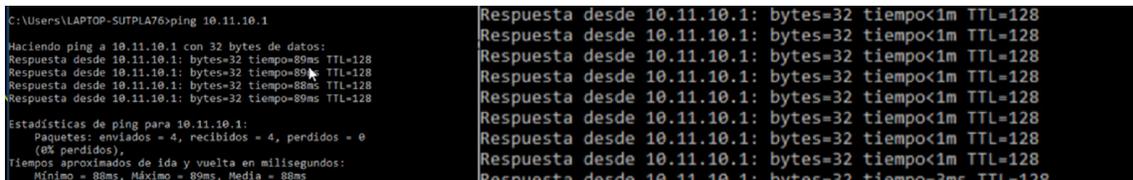
FIGURE 3. (Left) Ping Reply With Problems, (Right) Normal Ping Reply in a LAN

I suspected it was a network problem or some blocking caused by the firewall or antivirus. I checked with Wireshark and basically it was receiving packets from the POS MV and the Echosounder, so I decided to run the command "ping -t", which pings the desired IP until I stop the command. When I got the reply from the SeaBat IP address I realized the ping reply was taking around 89 ms, and for a local area connection it should be close to or even less than 1 ms.

After that I was almost sure something was affecting the network connection so I check the Ethernet interface and voila, the network interface was working at 100 Mbps (Fast Ethernet), so I assumed it wasn't enough bandwidth to receive all of the packages from the SeaBat and POS MV.

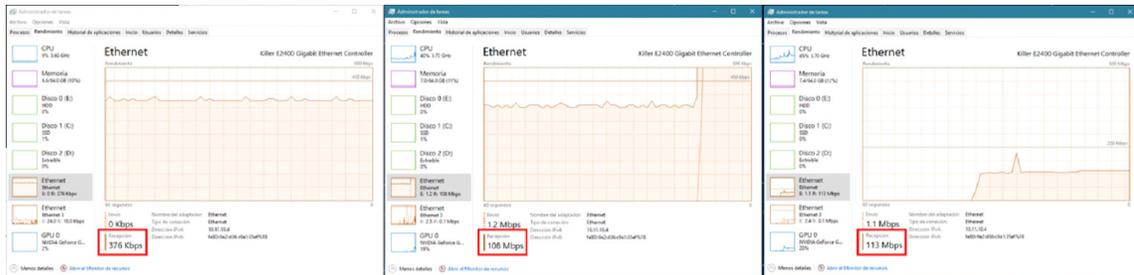
FIGURE 4. (Left) Only Packets Coming From the POS MV, (Center) POS MV and SeaBat UI Working, (Right) POS MV, SeaBat UI and HYPACK® Running

We started testing the POS MV data only, then we started the SeaBat UI and HYPACK. We realized SeaBat UI and POS MV needed at least 108 Mbps, which exceeds the maximum bandwidth for a Fast Ethernet connection. Then we started the POS MV (with POSView

opened, SeaBat UI, and HYPACK). It was using around 113 Mbps. That explains why some packets took more time to be received by the computer.

To check the network resources, you can open the Task Manager and go to the Performance tab. It will show a graph with the real time bandwidth used. You only have to interpret the information.

If your network interface is not working with a Gigabit connection, you should check the cable (recommended UTP CAT5e or CAT6), network switch with Gigabit ports and windows configuration. In some cases Windows does not negotiate a Gigabit connection, only a Fast Ethernet.
